PRELIMINARY ASSESSMENT REPORT

LANE STREET GROUND WATER CONTAMINATION

ELKHART, INDIANA

OCTOBER 5, 2007

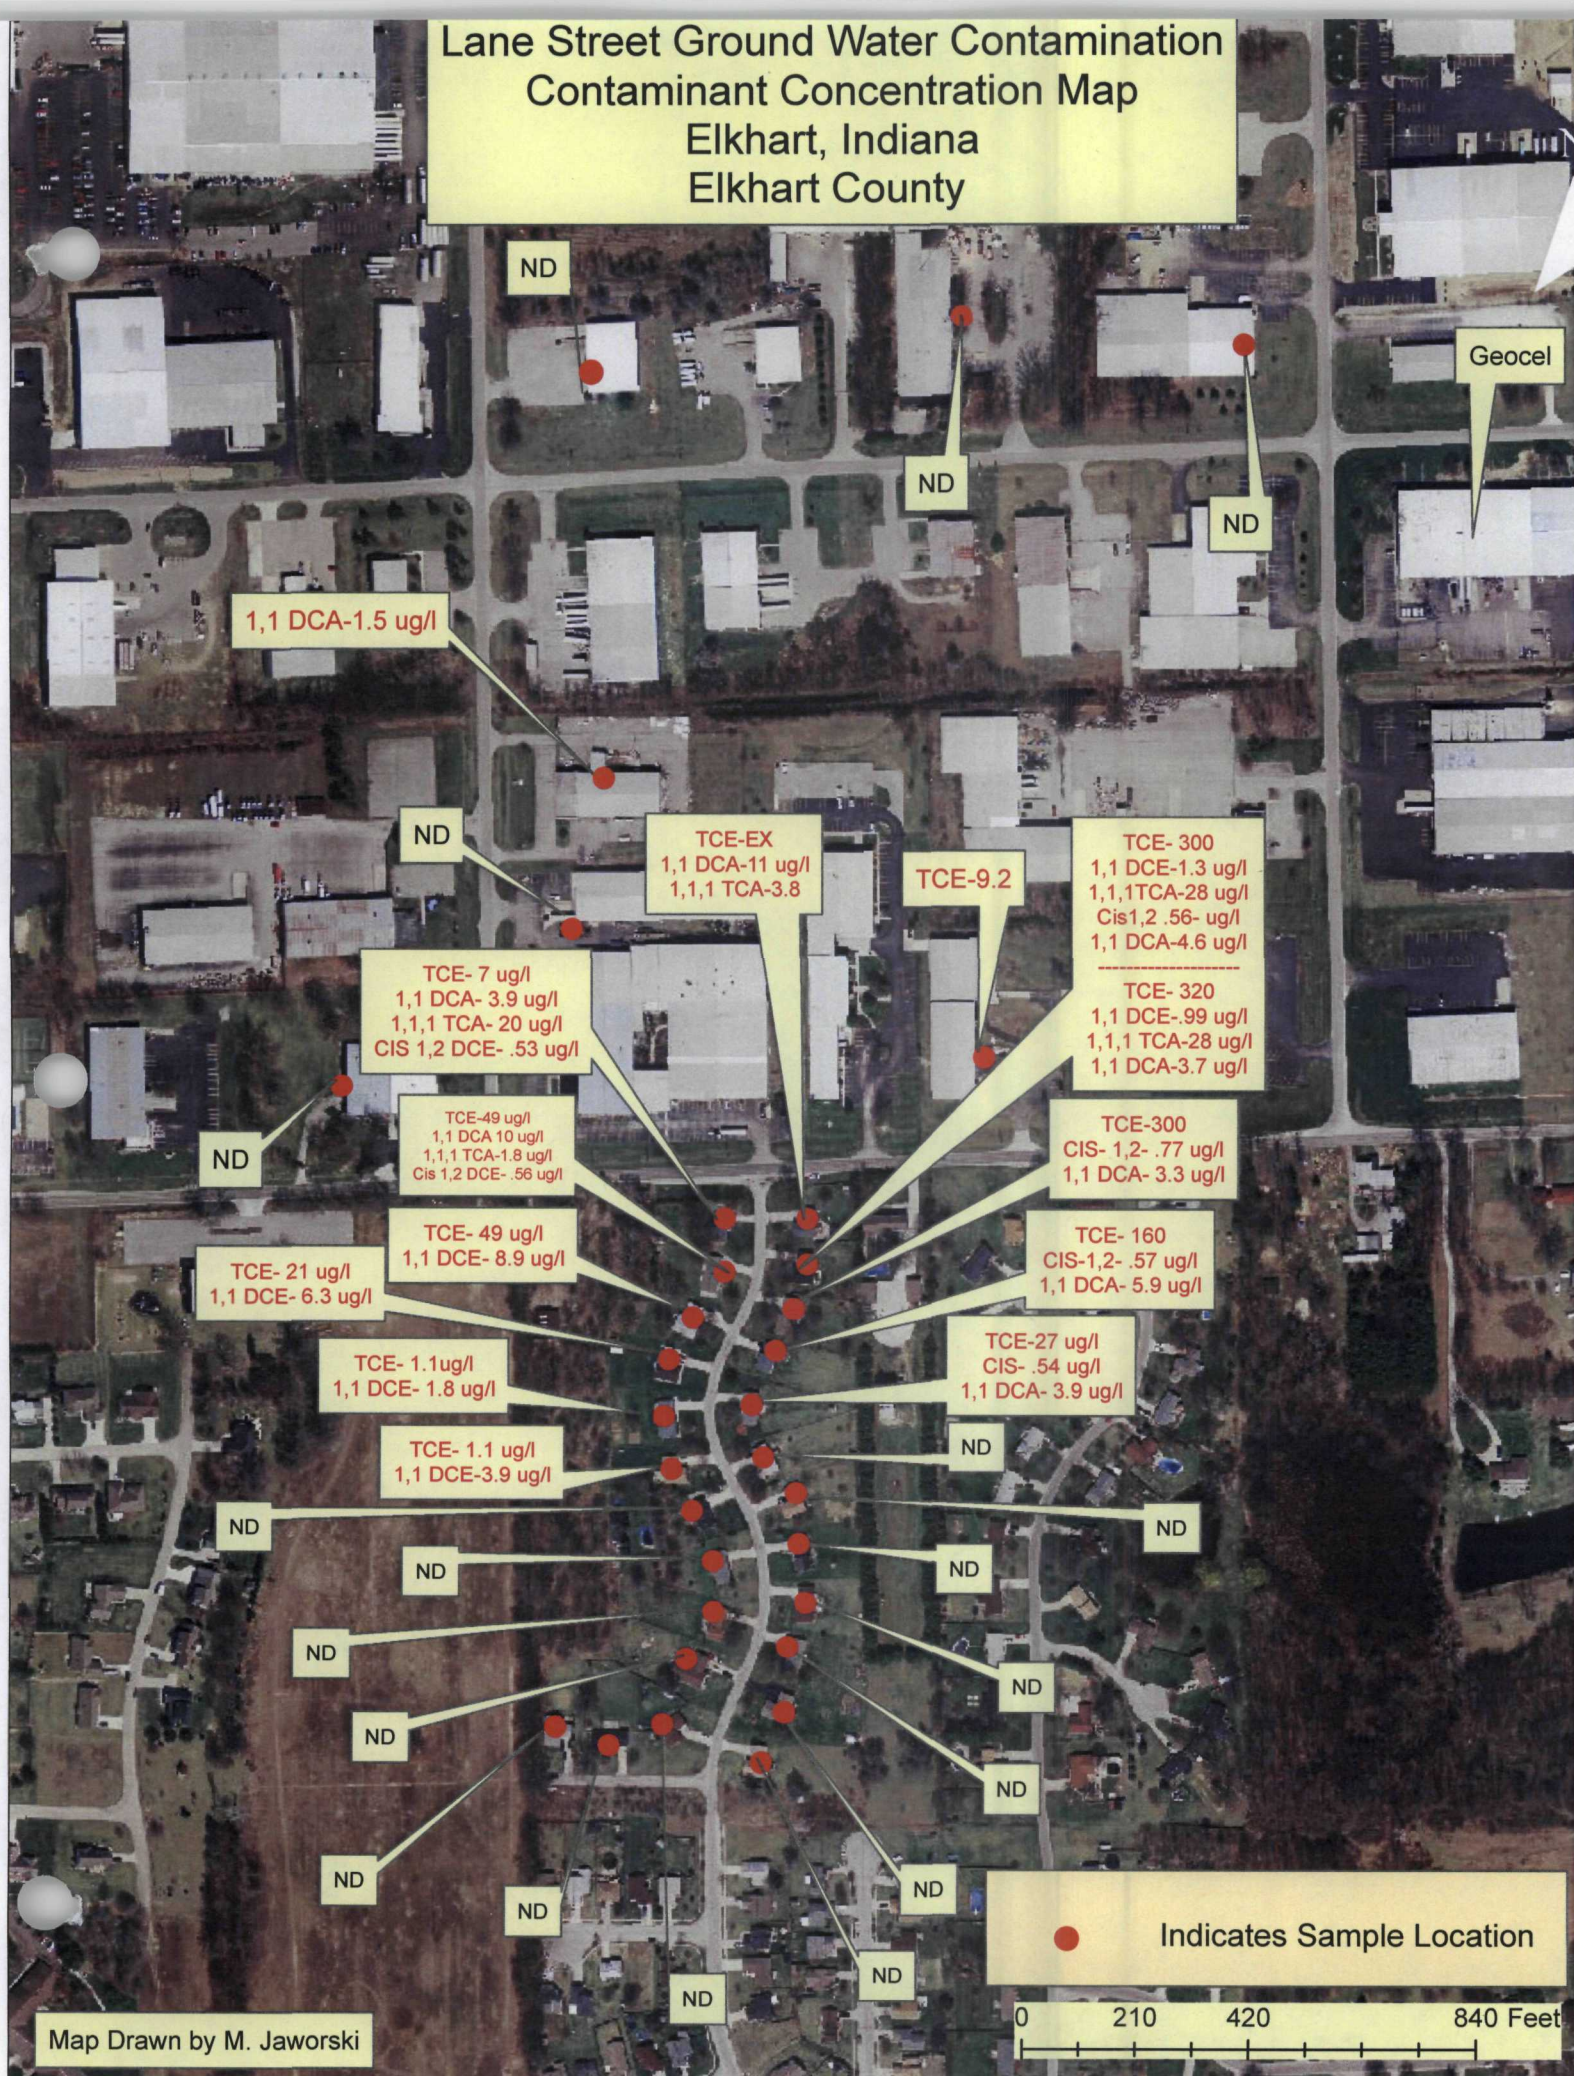
Sample results from the August 30 sampling event indicate that the water from eleven residential wells and two business wells were found to contain elevated levels of volatile organic compounds (VOCs). Refer to the Contaminant Concentration Map on Page 4-4 for a detailed description and concentration of the VOCs detected. The map also shows the location of all detected contaminants.

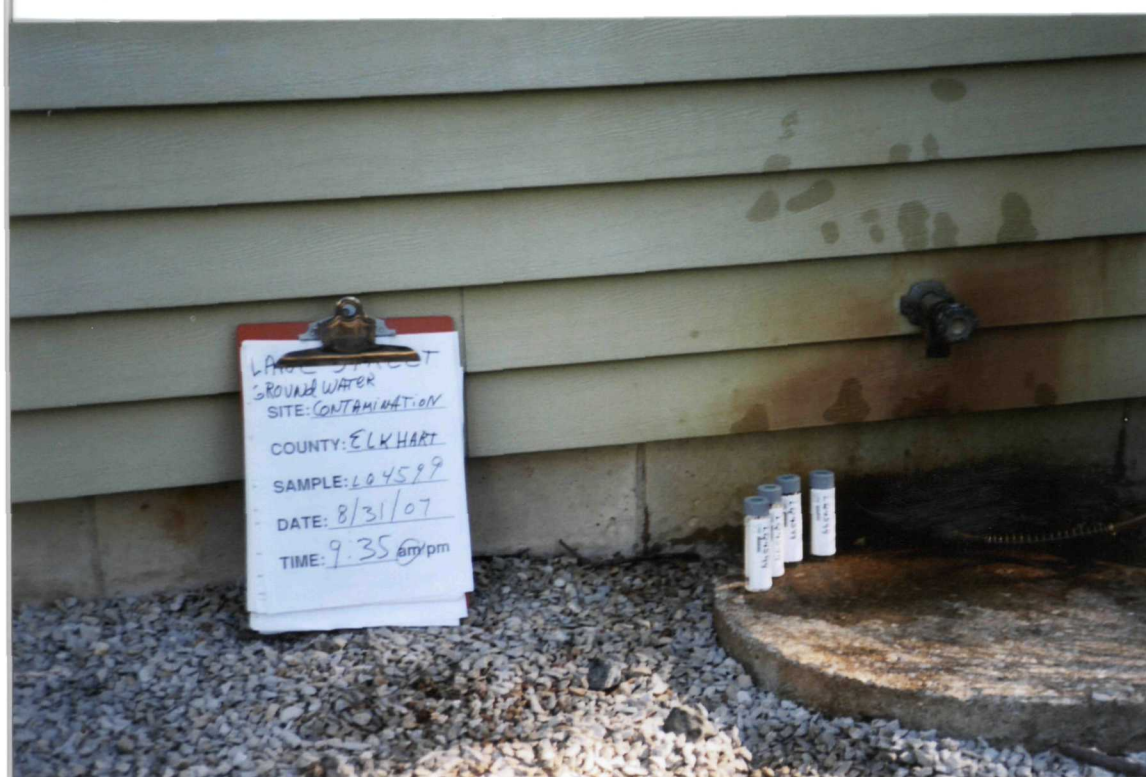
SITE: Lane Street Ground Water Contamination  
EPA ID#: INN000510229  
DATE: 8/31/07  
TIME: 9:35 am  
WEATHER: Sunny; 80s °  
SAMPLE ID# LQ 4599  
SAMPLE TYPE: Ground Water  
DESCRIPTION: Ground water sample obtained from 53535 Lane Street

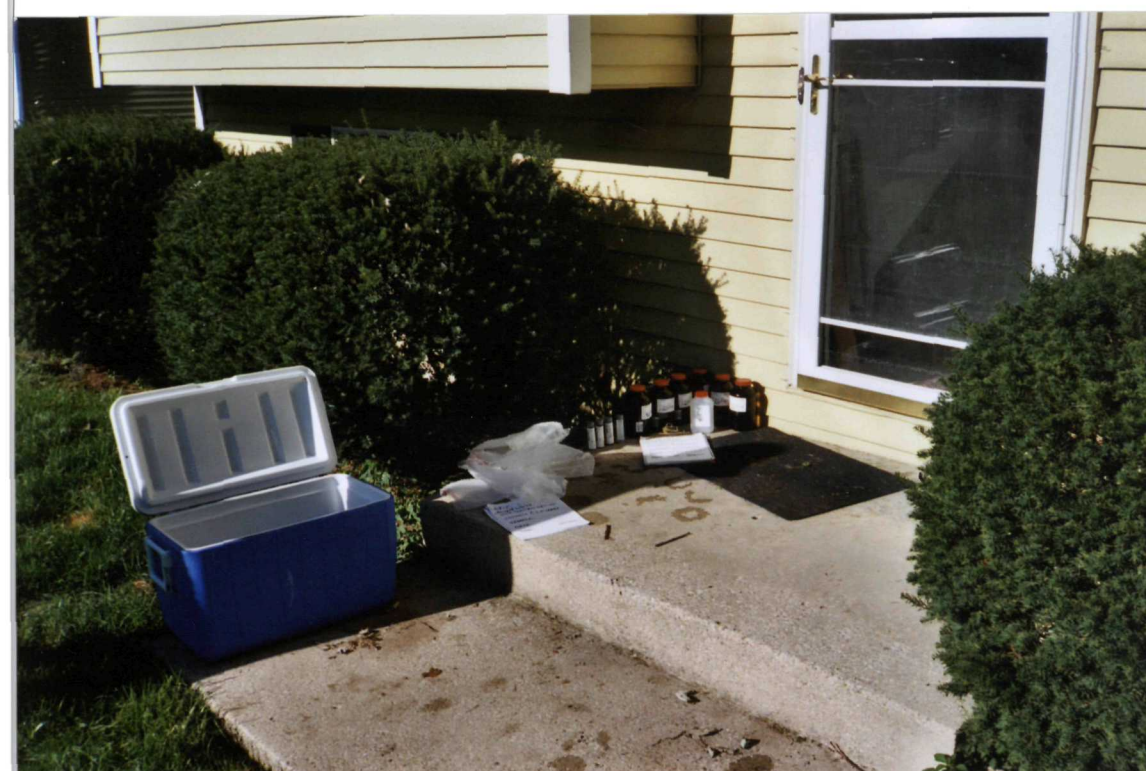
SITE: Lane Street Ground Water Contamination  
EPA ID#: INN000510229  
DATE: 8/31/07  
TIME: 9:25 am  
WEATHER: Sunny; 80s °  
SAMPLE ID# LQ 4598  
SAMPLE TYPE: Ground Water  
DESCRIPTION: Picture shows the area where sample LQ4598 was obtained

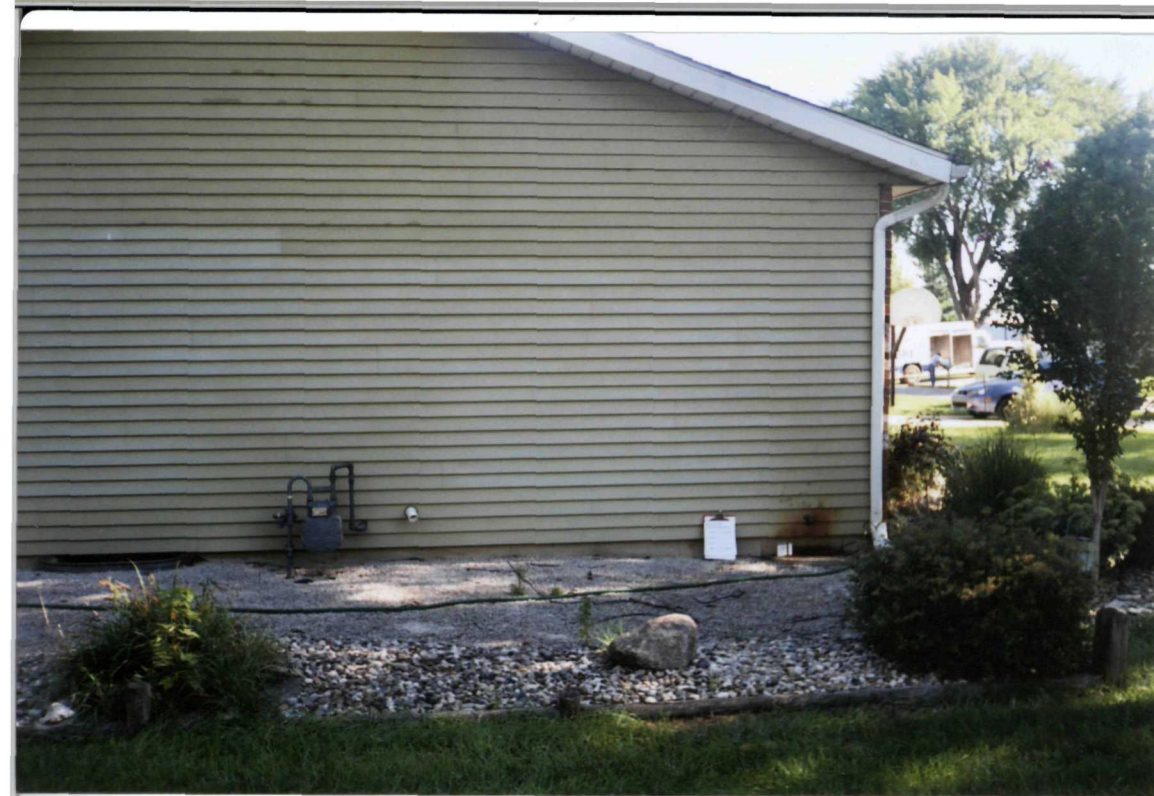
**SITE: Lane Street Ground Water Contamination**  
**EPA ID#: INN000510229**  
**DATE: 8/31/07**  
**TIME: 9:35 am**  
**WEATHER: Sunny; 80s °**  
**SAMPLE ID# LQ 4599**  
**SAMPLE TYPE: Ground Water**  
**DESCRIPTION: Picture shows the area where sample LQ4599 was obtained**

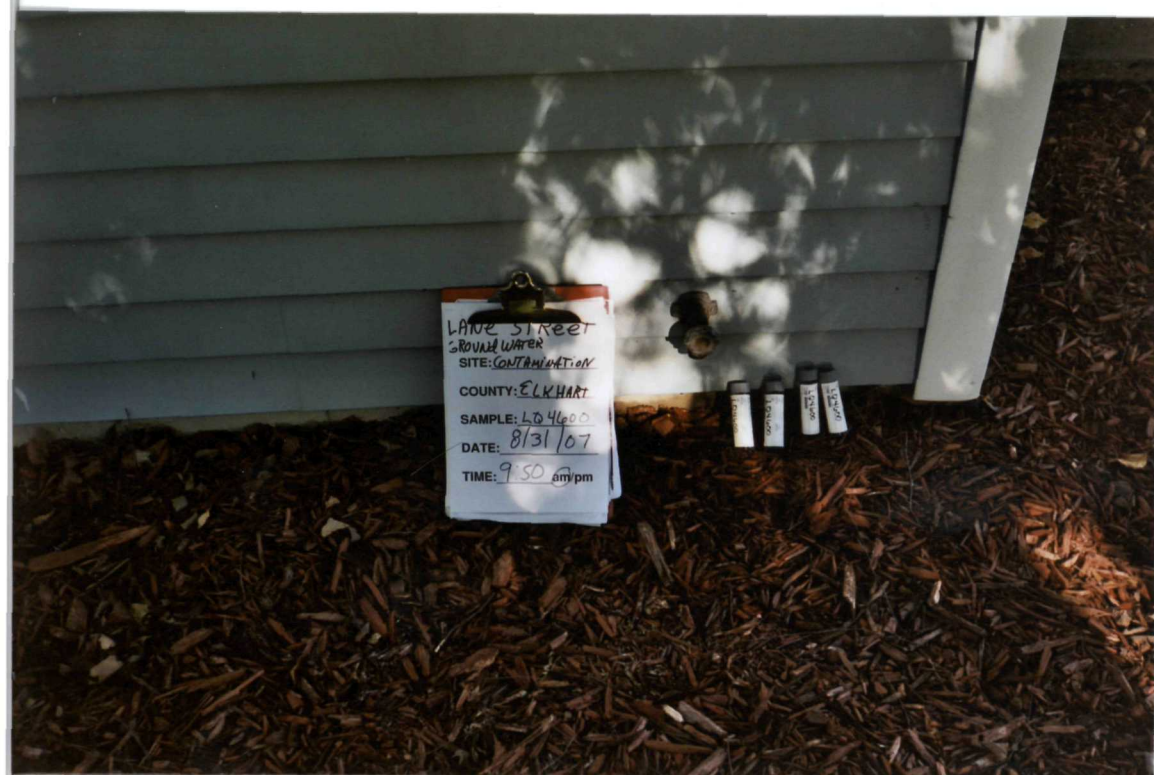
**SITE: Lane Street Ground Water Contamination**  
**EPA ID#: INN000510229**  
**DATE: 8/31/07**  
**TIME: 9:50 am**  
**WEATHER: Sunny; 80s °**  
**SAMPLE ID# LQ 4600**  
**SAMPLE TYPE: Ground Water**  
**DESCRIPTION: Ground water sample obtained from Lane Street**

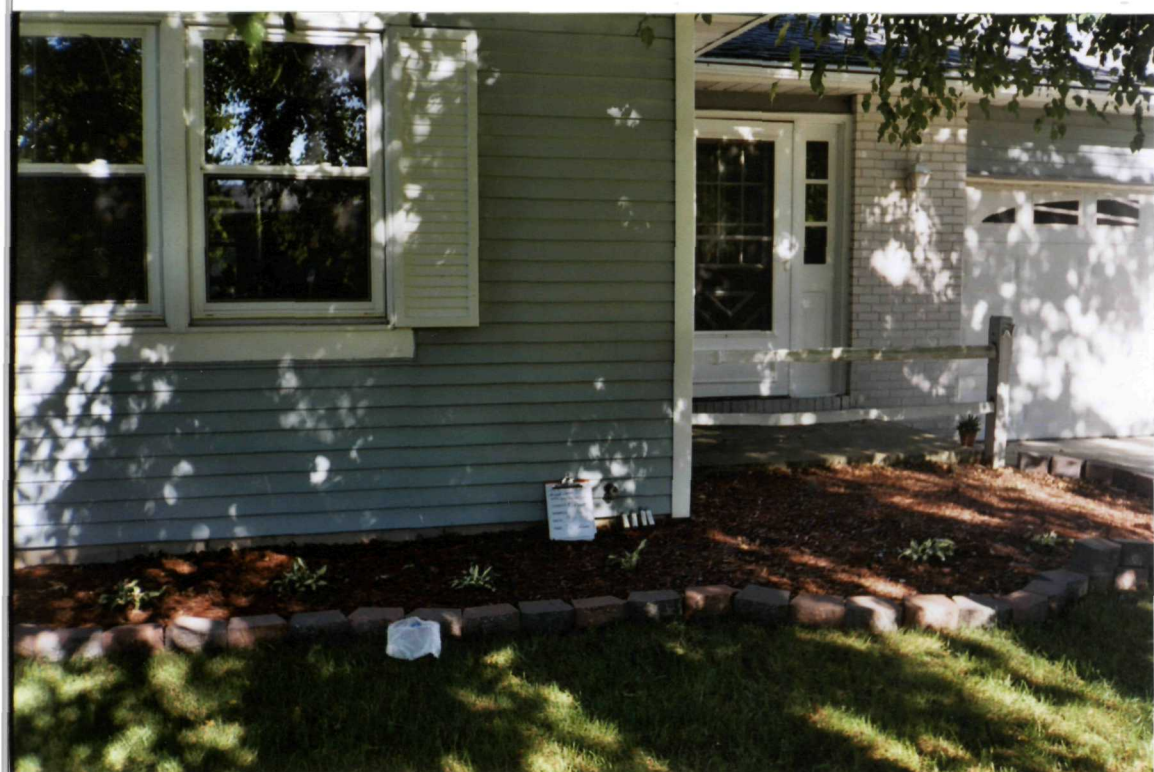
**SITE: Lane Street Ground Water Contamination**  
**EPA ID#: INN000510229**  
**DATE: 8/31/07**  
**TIME: 9:50 am**  
**WEATHER: Sunny; 80s °**  
**SAMPLE ID# LQ 4600**  
**SAMPLE TYPE: Ground Water**  
**DESCRIPTION: Picture shows the area where sample LQ4600 was obtained**

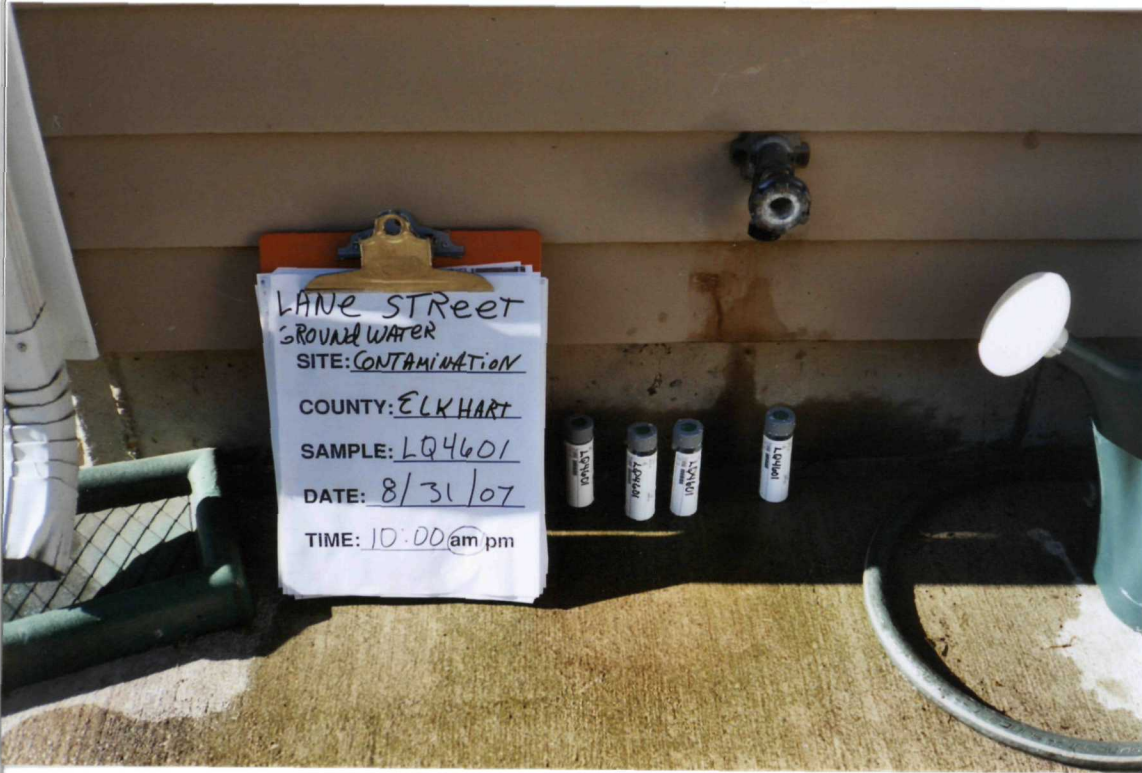
SITE: Lane Street Ground Water Contamination  
EPA ID#: INN000510229  
DATE: 8/31/07  
TIME: 10:00 am  
WEATHER: Sunny; 80s °  
SAMPLE ID# LQ 4601  
SAMPLE TYPE: Ground Water  
DESCRIPTION: Ground water sample obtained from 53569 Lane Street

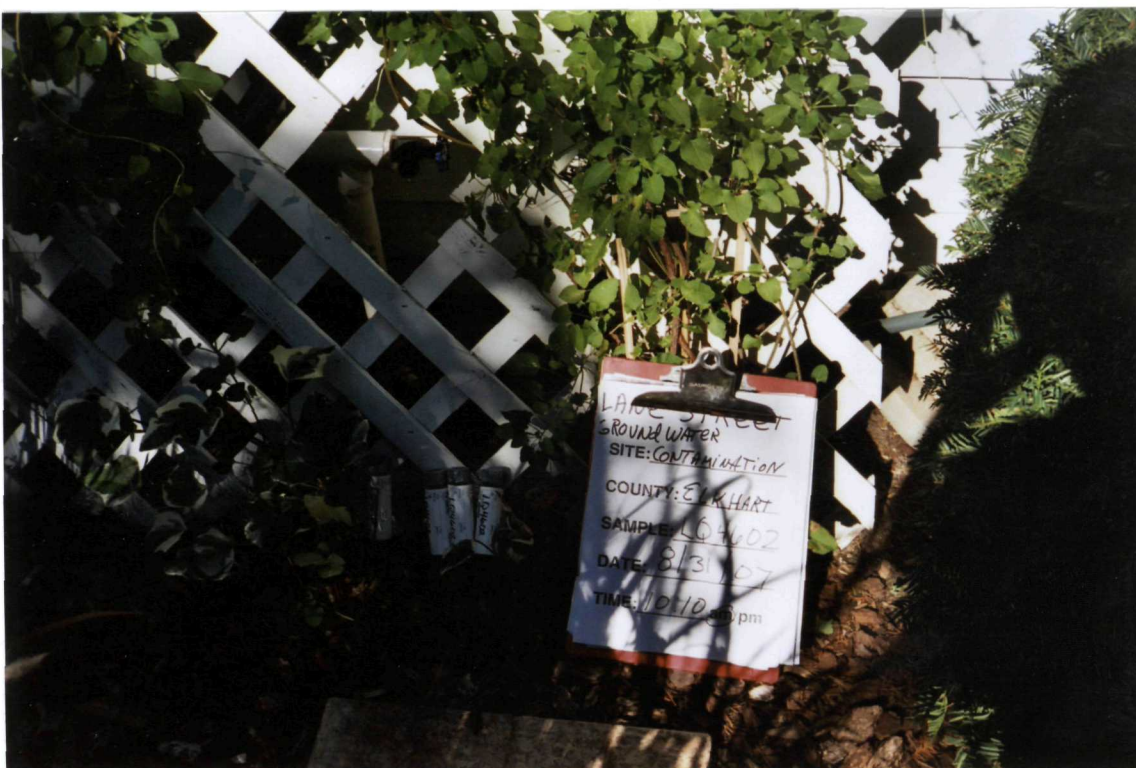
SITE: Lane Street Ground Water Contamination  
EPA ID#: INN000510229  
DATE: 8/31/07  
TIME: 10:10 am  
WEATHER: Sunny; 80s °  
SAMPLE ID# LQ 4602  
SAMPLE TYPE: Ground Water  
DESCRIPTION: Ground water sample obtained from 53585 Lane Street

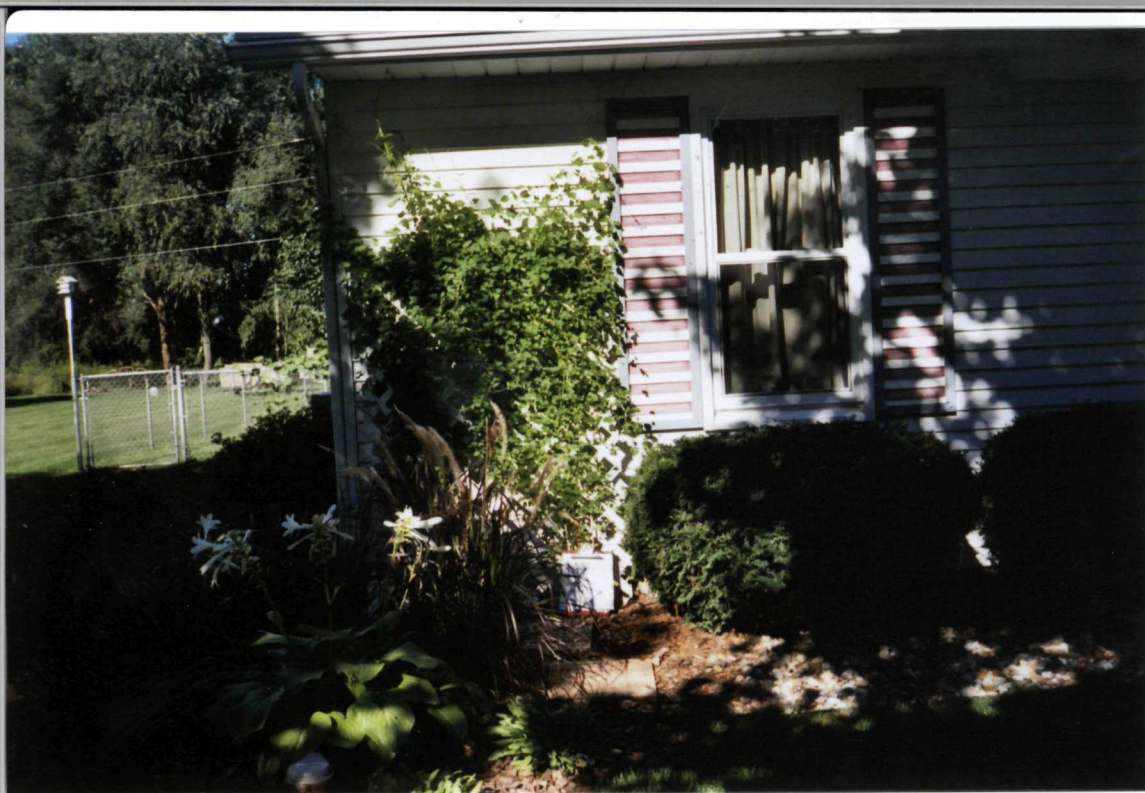
**SITE: Lane Street Ground Water Contamination**  
**EPA ID#: INN000510229**  
**DATE: 8/31/07**  
**TIME: 10:10 am**  
**WEATHER: Sunny; 80s °**  
**SAMPLE ID# LQ 4602**  
**SAMPLE TYPE: Ground Water**  
**DESCRIPTION: Picture shows the area where sample LQ4602 was obtained**

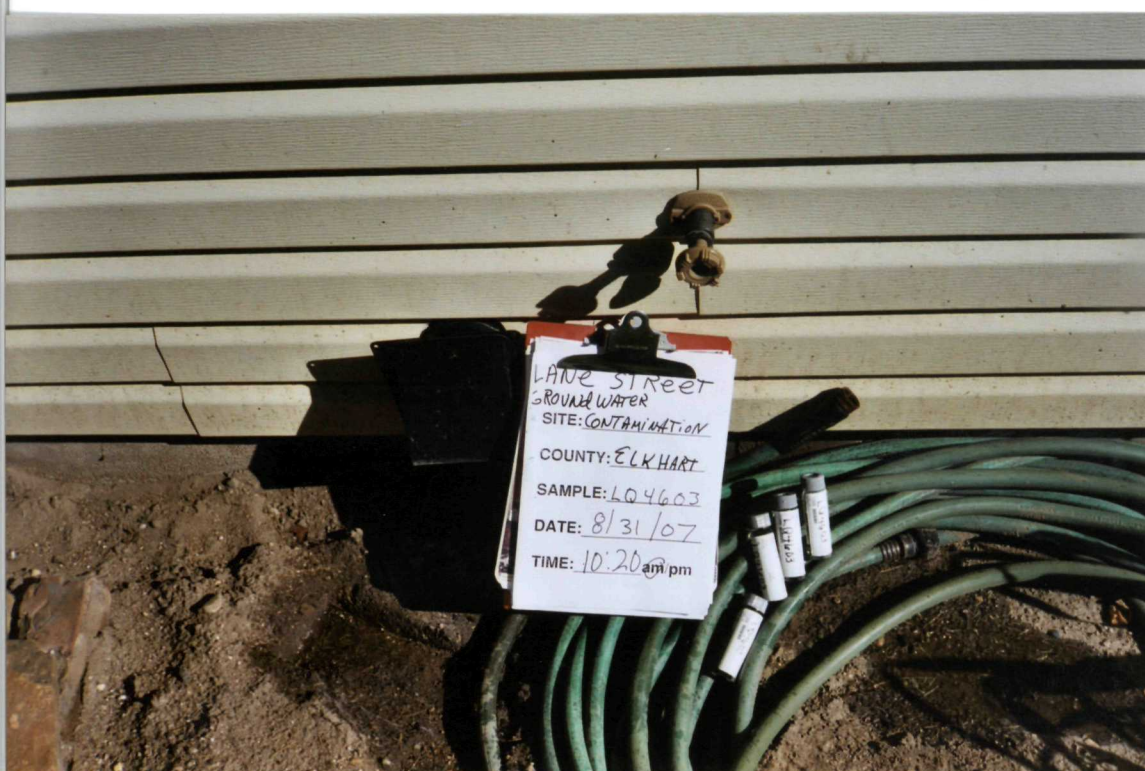
**SITE: Lane Street Ground Water Contamination**  
**EPA ID#: INN000510229**  
**DATE: 8/31/07**  
**TIME: 10:20 am**  
**WEATHER: Sunny; 80s °**  
**SAMPLE ID# LQ 4603**  
**SAMPLE TYPE: Ground Water**  
**DESCRIPTION: Ground water sample obtained from 53601 Lane Street**

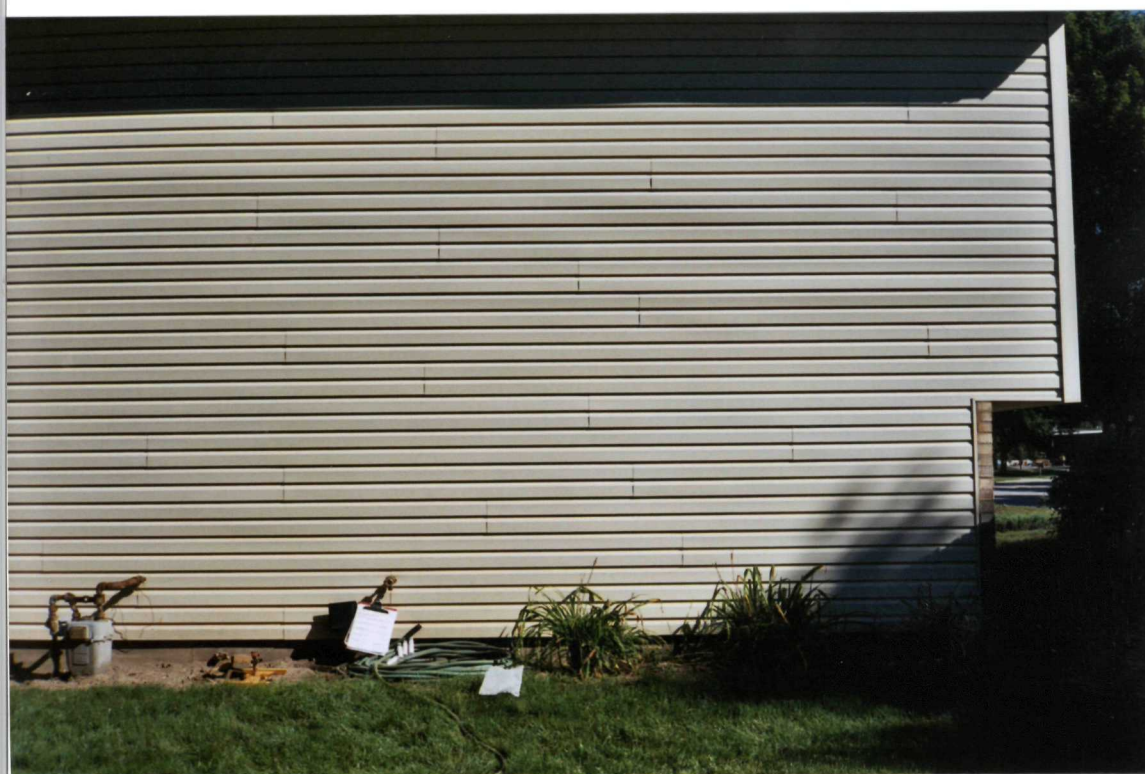
**SITE: Lane Street Ground Water Contamination**  
**EPA ID#: INN000510229**  
**DATE: 8/31/07**  
**TIME: 10:20 am**  
**WEATHER: Sunny; 80s °**  
**SAMPLE ID# LQ 4603**  
**SAMPLE TYPE: Ground Water**  
**DESCRIPTION: Picture shows the area where sample LQ4603 was obtained**

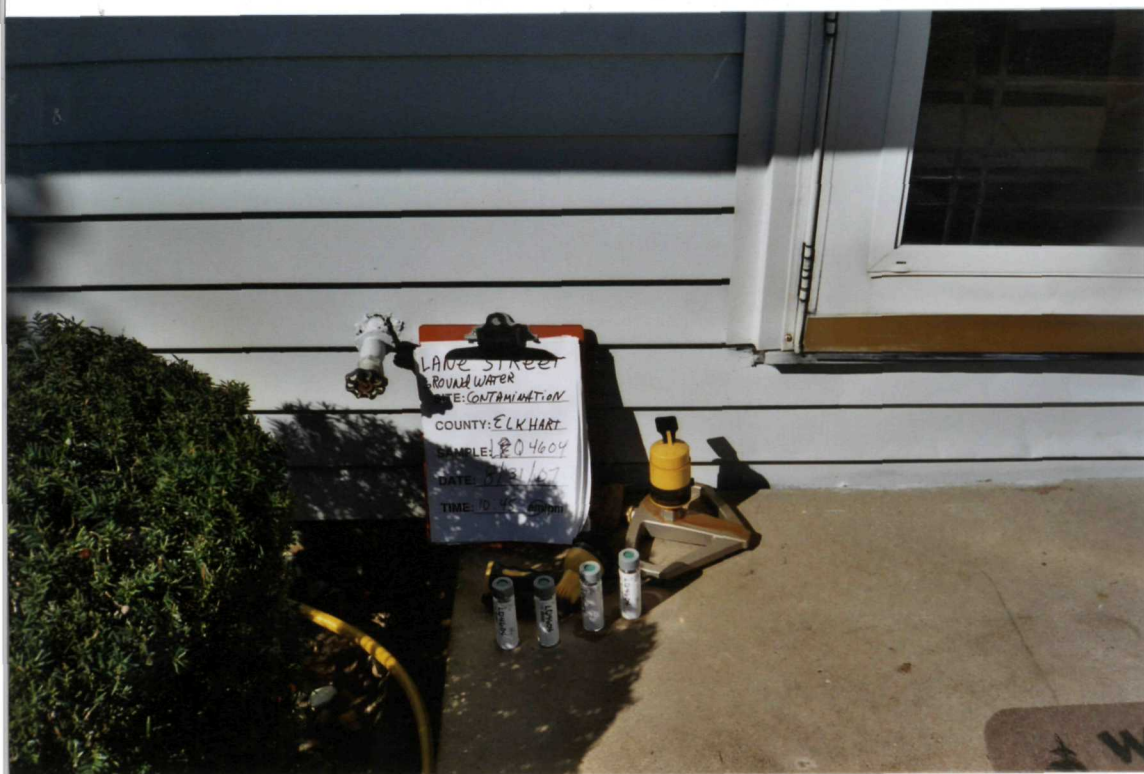
**SITE: Lane Street Ground Water Contamination**  
**EPA ID#: INN000510229**  
**DATE: 8/31/07**  
**TIME: 10:45 am**  
**WEATHER: Sunny; 80s °**  
**SAMPLE ID# LQ 4604**  
**SAMPLE TYPE: Ground Water**  
**DESCRIPTION: Ground water sample obtained from 53615 Lane Street**

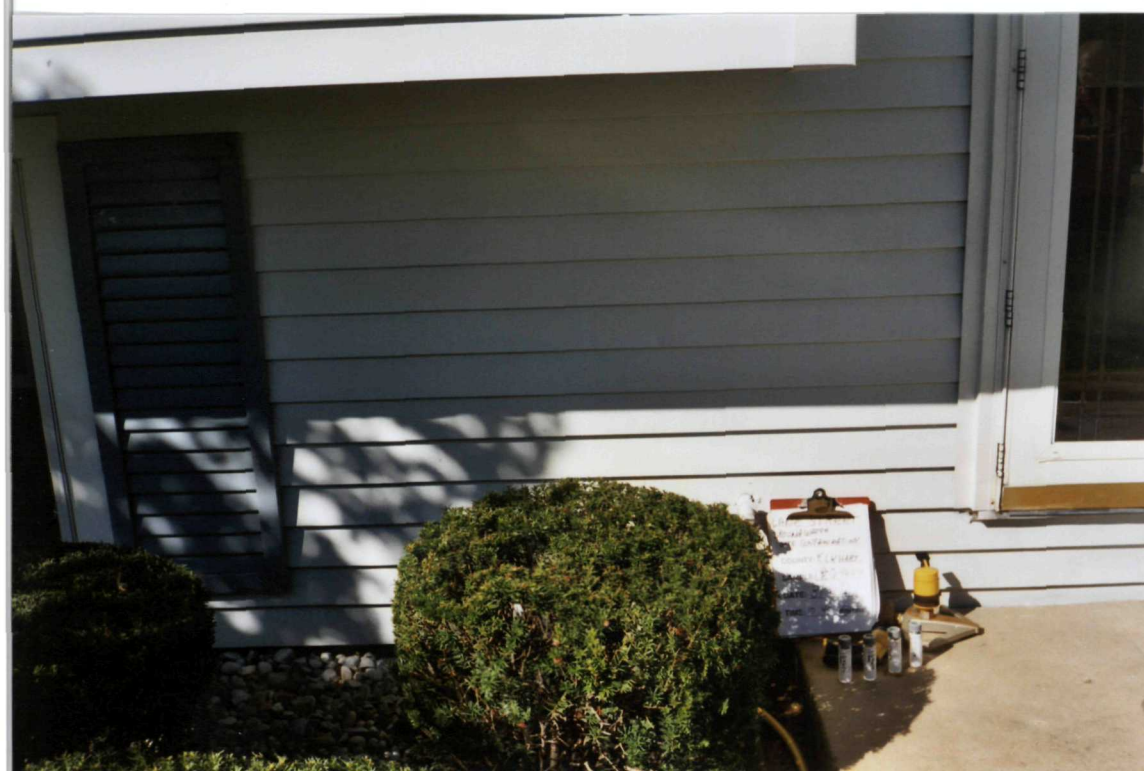
**SITE: Lane Street Ground Water Contamination**  
**EPA ID#: INN000510229**  
**DATE: 8/31/07**  
**TIME: 10:45 am**  
**WEATHER: Sunny; 80s °**  
**SAMPLE ID# LQ 4604**  
**SAMPLE TYPE: Ground Water**  
**DESCRIPTION: Picture shows the area where sample LQ4604 was obtained**

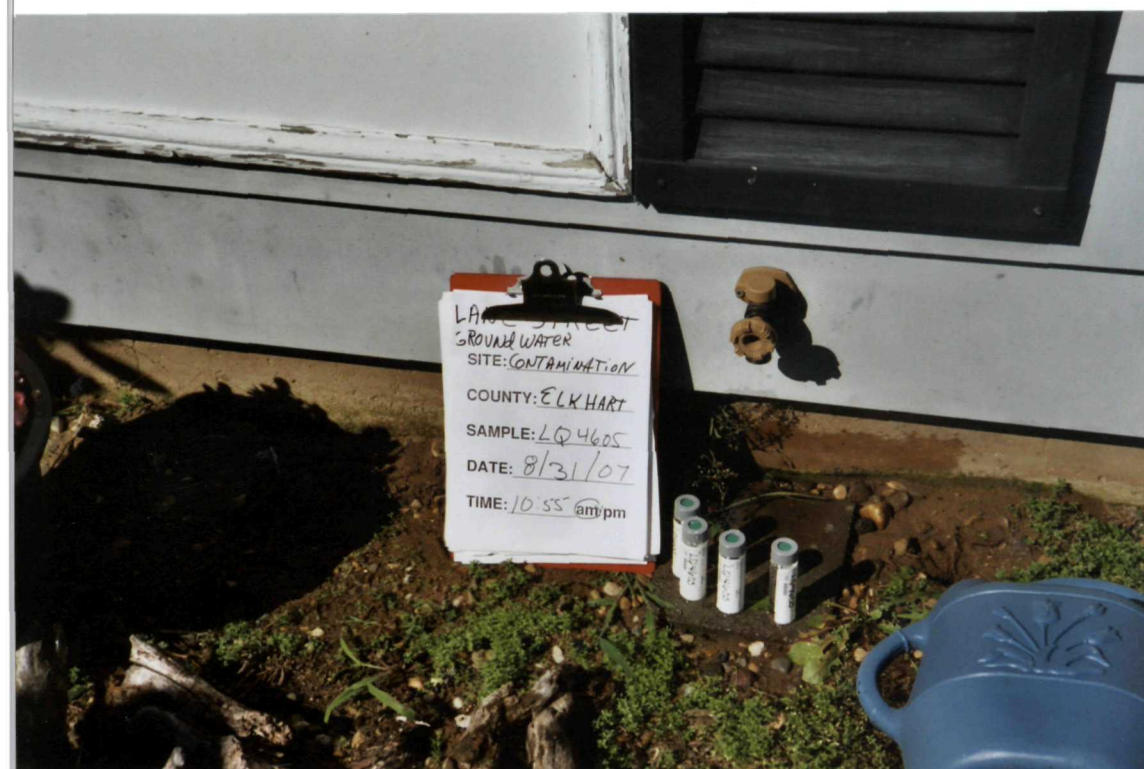
**SITE: Lane Street Ground Water Contamination**  
**EPA ID#: INN000510229**  
**DATE: 8/31/07**  
**TIME: 10:55 am**  
**WEATHER: Sunny; 80s °**  
**SAMPLE ID# LQ 4605**  
**SAMPLE TYPE: Ground Water**  
**DESCRIPTION: Ground water sample obtained from 53635 Lane Street**

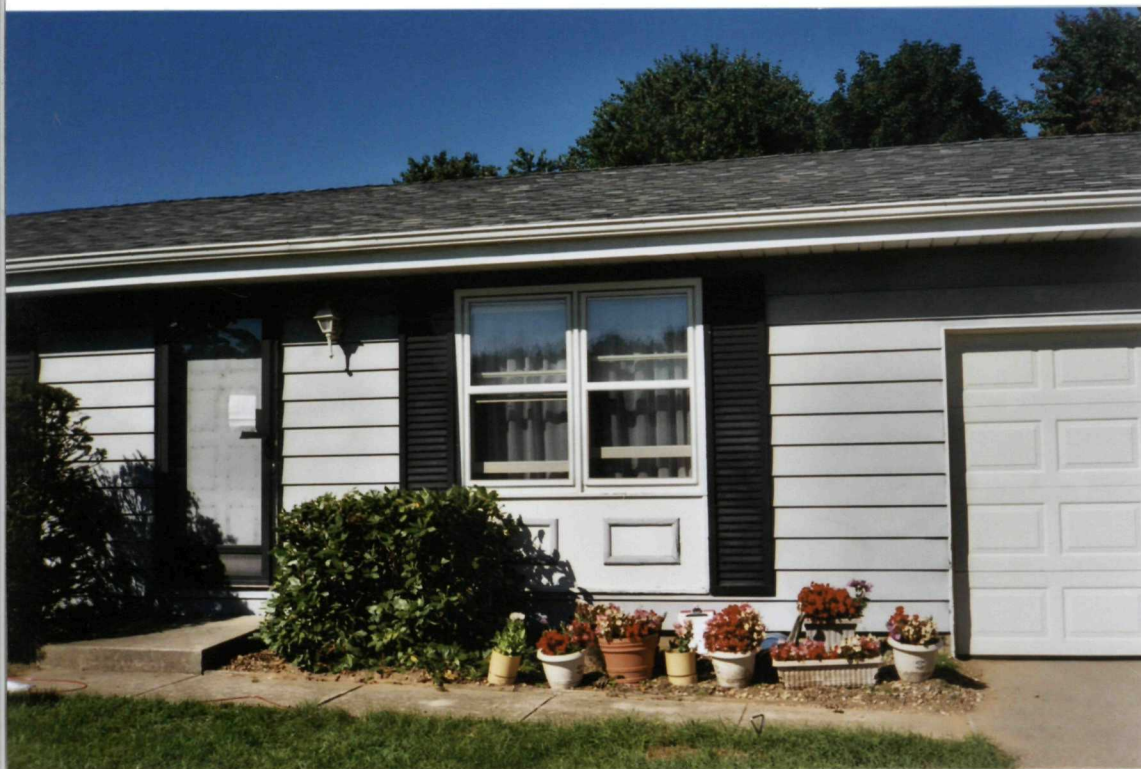
**SITE: Lane Street Ground Water Contamination**  
**EPA ID#: INN000510229**  
**DATE: 8/31/07**  
**TIME: 10:55 am**  
**WEATHER: Sunny; 80s °**  
**SAMPLE ID# LQ 4605**  
**SAMPLE TYPE: Ground Water**  
**DESCRIPTION: Picture shows the area where sample LQ4605 was obtained**

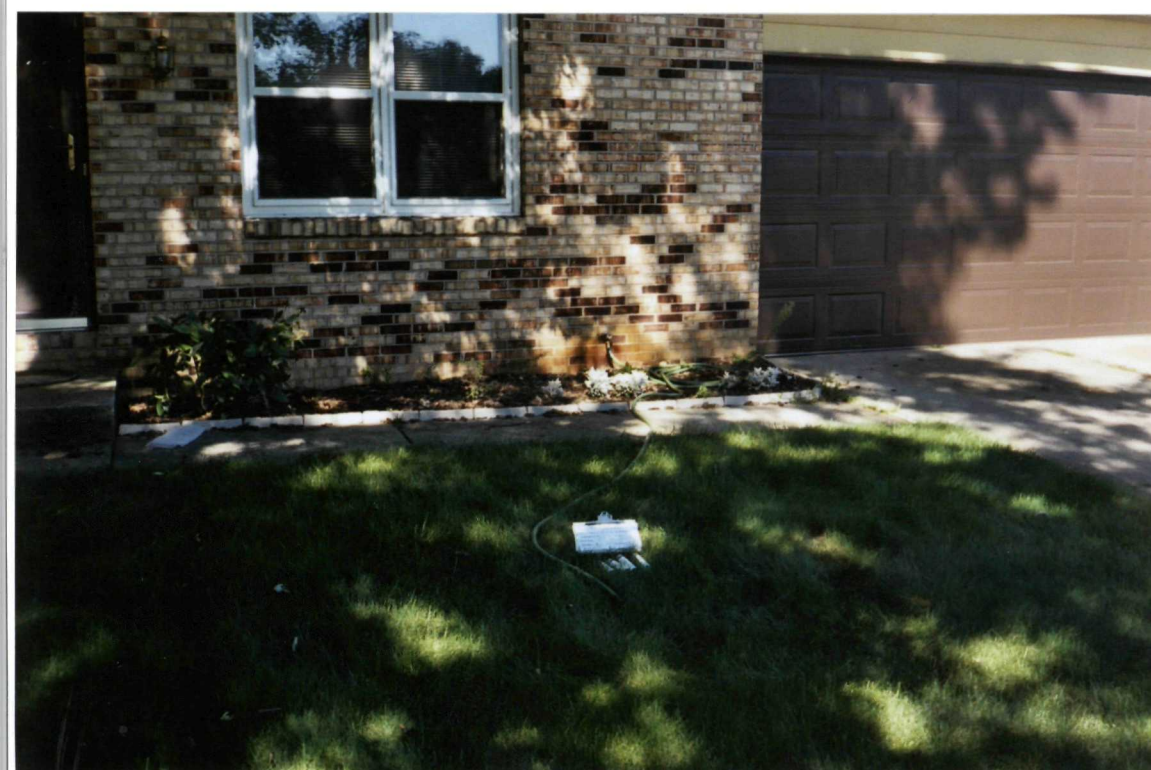
**SITE: Lane Street Ground Water Contamination**  
**EPA ID#: INN000510229**  
**DATE: 8/31/07**  
**TIME: 11:10 am**  
**WEATHER: Sunny; 80s °**  
**SAMPLE ID# LQ 4606**  
**SAMPLE TYPE: Ground Water**  
**DESCRIPTION: Picture shows the area where sample LQ4606 was obtained**

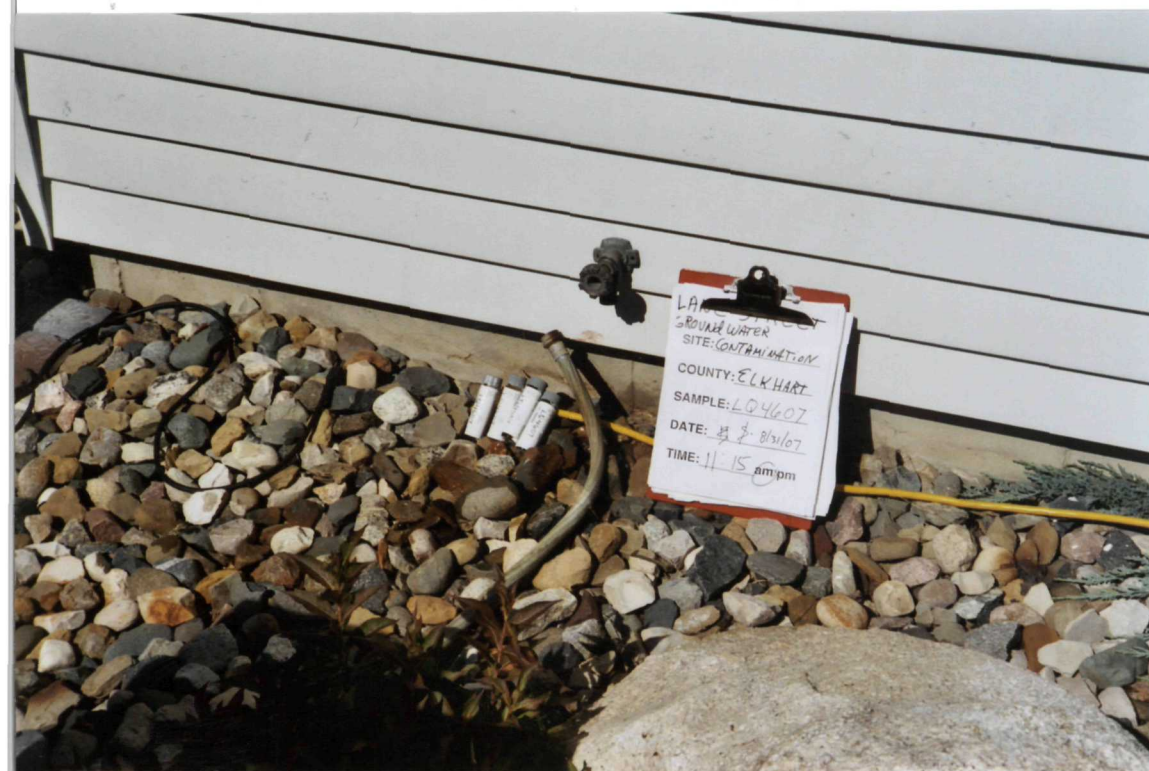
**SITE: Lane Street Ground Water Contamination**  
**EPA ID#: INN000510229**  
**DATE: 8/31/07**  
**TIME: 11:15 am**  
**WEATHER: Sunny; 80s °**  
**SAMPLE ID# LQ 4607**  
**SAMPLE TYPE: Ground Water**  
**DESCRIPTION: Ground water sample obtained from 53677 Lane Street**

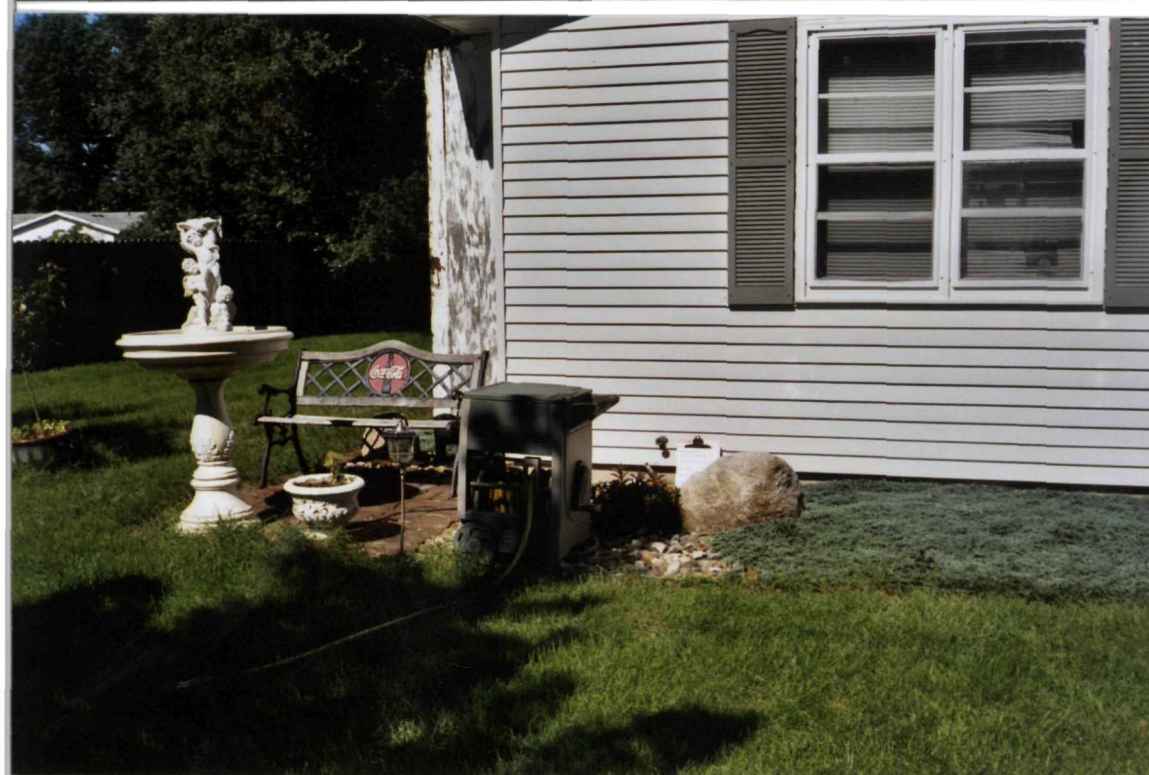
**SITE: Lane Street Ground Water Contamination**  
**EPA ID#: INN000510229**  
**DATE: 8/31/07**  
**TIME: 11:15 am**  
**WEATHER: Sunny; 80s °**  
**SAMPLE ID# LQ 4607**  
**SAMPLE TYPE: Ground Water**  
**DESCRIPTION: Picture shows the area where sample LQ4407 was obtained**

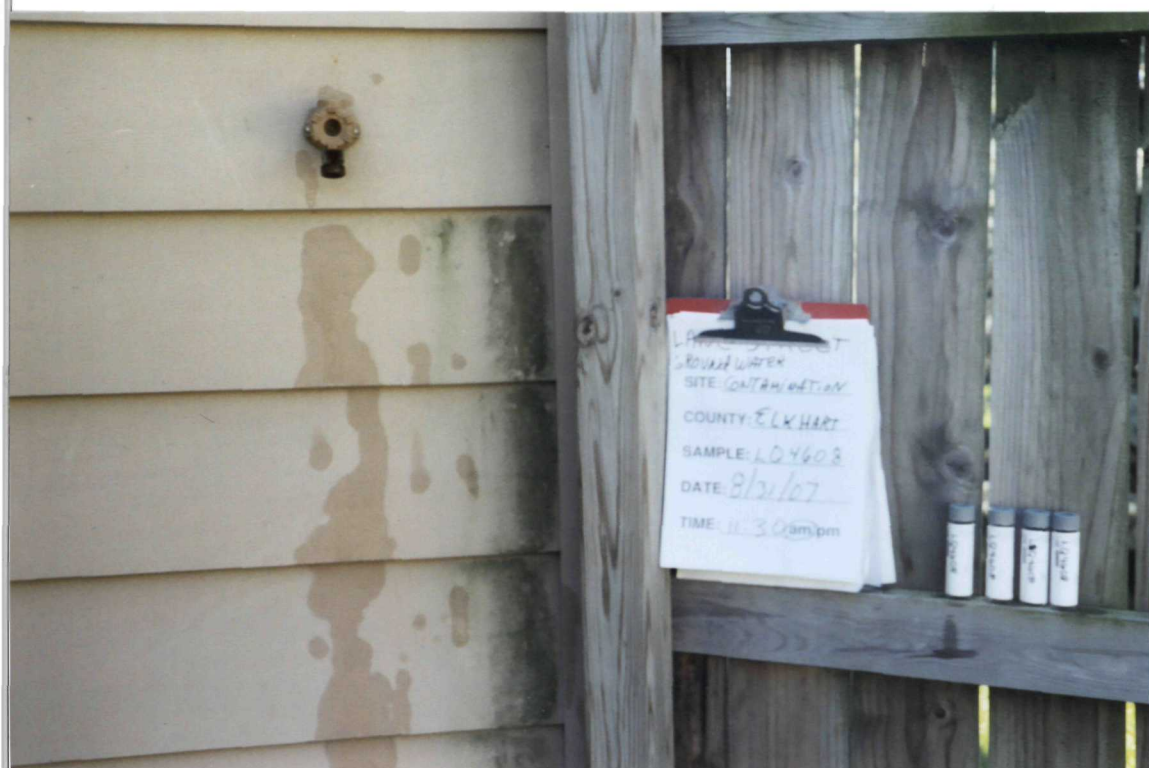
**SITE: Lane Street Ground Water Contamination**  
**EPA ID#: INN000510229**  
**DATE: 8/31/07**  
**TIME: 11:30 am**  
**WEATHER: Sunny; 80s °**  
**SAMPLE ID# LQ 44608**  
**SAMPLE TYPE: Ground Water**  
**DESCRIPTION: Ground water sample obtained from 53695 Lane Street**

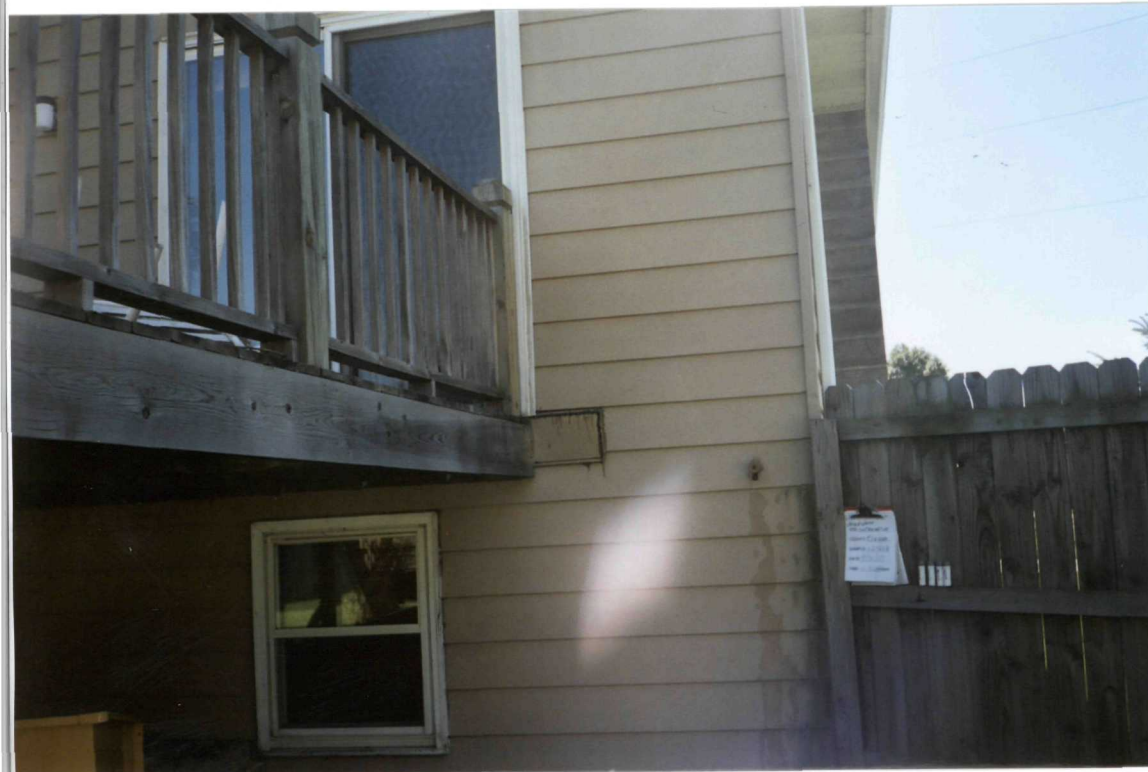
**SITE: Lane Street Ground Water Contamination**  
**EPA ID#: INN000510229**  
**DATE:8/31/07**  
**TIME: 11:30 am**  
**WEATHER: Sunny; 80s °**  
**SAMPLE ID# LQ 4608**  
**SAMPLE TYPE: Ground Water**  
**DESCRIPTION: Picture shows the area where sample LQ4608 was obtained**

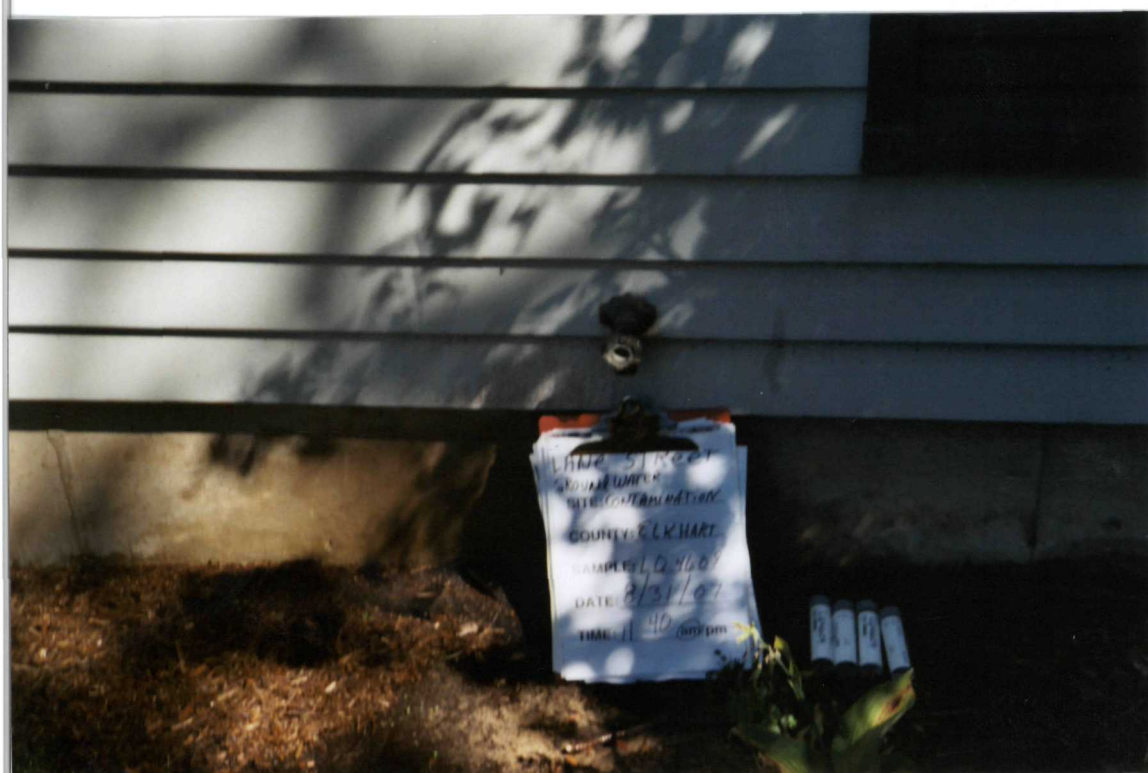
**SITE: Lane Street Ground Water Contamination**  
**EPA ID#: INN000510229**  
**DATE:8/31/07**  
**TIME: 11:40 am**  
**WEATHER: Sunny; 80s °**  
**SAMPLE ID# LQ 4609**  
**SAMPLE TYPE: Ground Water**  
**DESCRIPTION: Ground water sample obtained from 23723 Barley Street**
